ONE JOB THAT DUCT TAPE COULD NOT DO

*Sometimes the answer
is baling wire.*

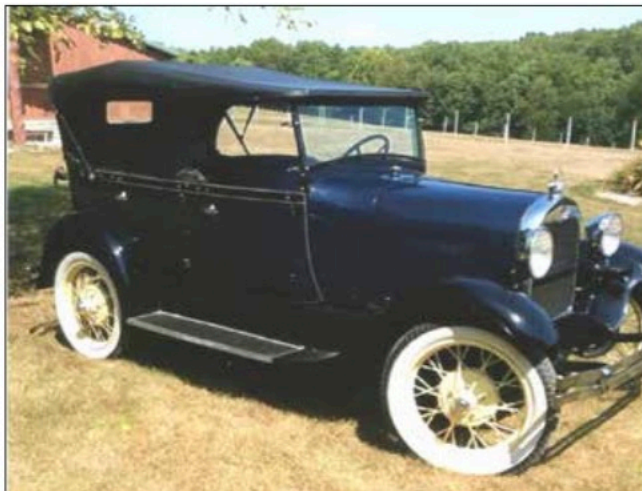
it through one hole of the bushing and back up the other. (See figure 2.) I put the steering wheel nut back on the steering shaft to prevent damage to the threads, wrapped the wire around a section of wooden closet rod, then used the steering shaft to create a fulcrum to pull out the bushing.

The combined effect of driving the rod, then pulling with the wire and fulcrum, enabled me to free the bushing.

After putting everything back together with the two felt pads in place, the rattle disappeared.

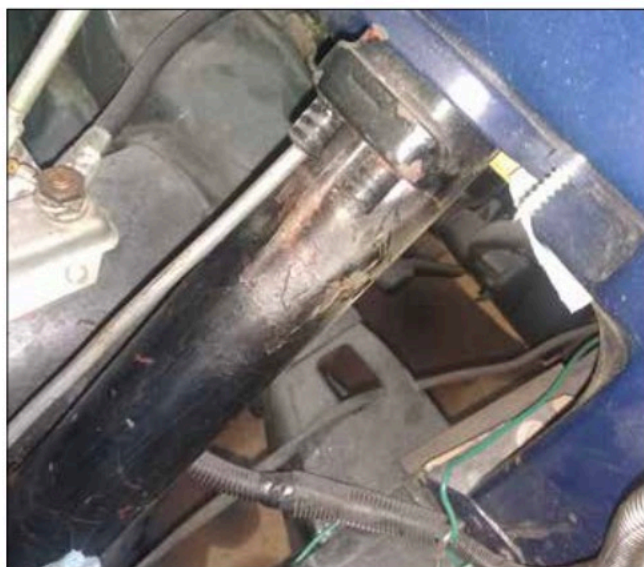
Figure 1: I put a $\frac{3}{16}$ " rod up the steering column.

AFTER REMOVING THE HORN, spark, and gas rods, I needed to remove the upper bushing assembly (A-3517). After much prying and probing, the bushing would still not move. I removed the left side splash pan and was able to put a $\frac{3}{16}$ " rod up the steering column. (See figure 1.) After several hits on the rod, it appeared that this also was not going to drive out the bushing.

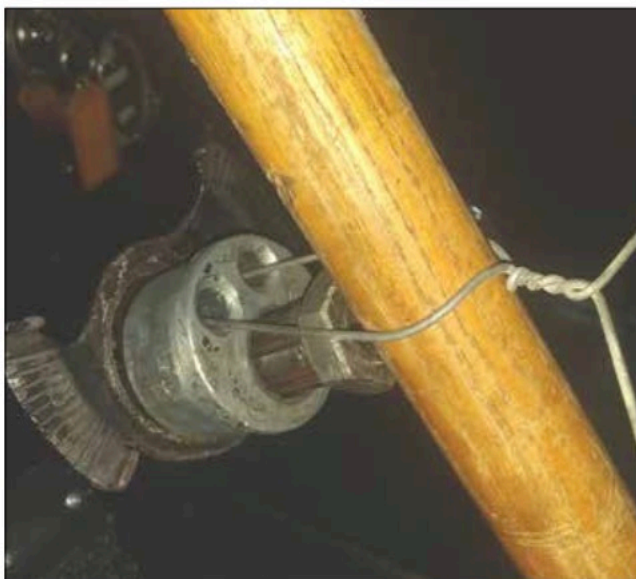
Figure 2: I threaded baling wire through the bushing and wrapped it around a section of closet rod.
