# 1928-1931 Model A/AA Ford Frame Anti-Squeak Material

By Steve Plucker, Prescott, Washington

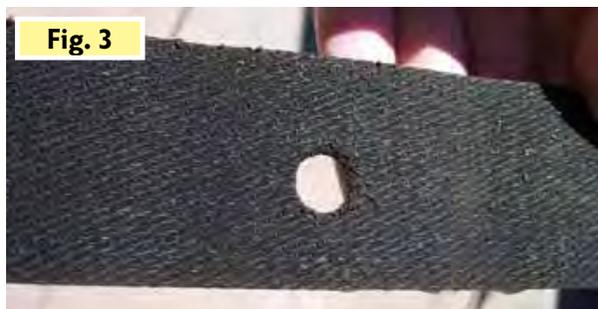
Fig. 3

The third sample (Fig. 3) is from an original A-16540 Running Board Shield to Frame Anti-Squeak strip showing the “Broken Twill Weave Napped Cotton Cloth”.

The PR also specified that “Changed material specifications note from M-Webbing (Figs. 1 and 2) to Broken Twill Weave Napped Cotton Cloth (Figs. 3 and 4) and was to be treated with the Asphaltum treatment.”

The “webbing” construction was the same “Broken Twill Weave Napped Cotton Cloth” as used with A-16540 and A-16541 (see **Fig’s 3 and 4 above**).

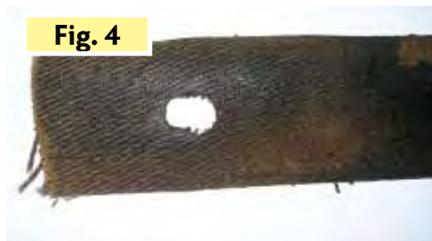
Fig. 4

The fourth sample (Fig. 4) is from a February-March 1929 Tudor Sedan which was assembled at the Seattle Assembly Plant showing the “Broken Twill Weave Napped Cotton Cloth”. This webbing has the same weave pattern as that which was also removed from a 1931 Victoria.

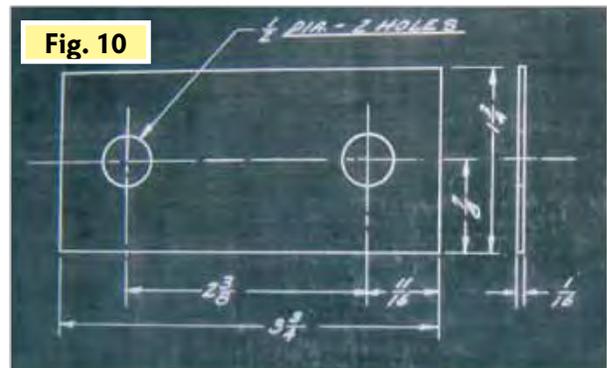
**Fig. 10**

On December 10, 1928, PR No. 11278, it became a “New number (A-35418), adopted” for use on the Model A and Model AA vehicles (Fig. 10).

Initially, the part was made of solid Black Rubber and had a Tensile Strength of 400 pounds per square inch. It was not reinforced with cloth as with the body block rubber pads.

The above photo (Fig. 11) shows an original solid “Black Rubber” A-35418 Coupe Pillar Bracket to Body Bracket Anti-Squeak which was on the February-March 1929 Tudor Sedan. The specs were as recorded on the Ford drawing (Fig. 10).
