## STAINLESS CAP DENT REMOVAL

Dave Westenberger – Colonial Virginia Model A Club

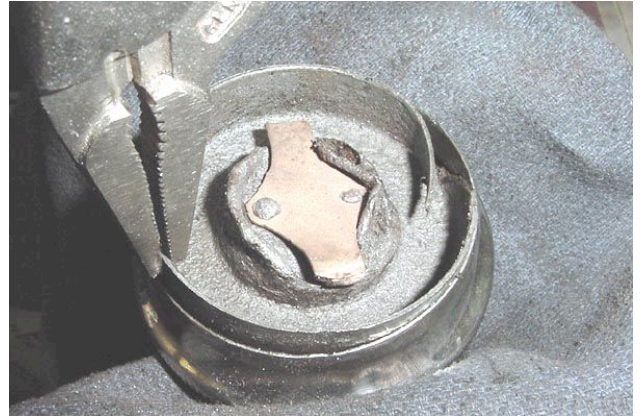
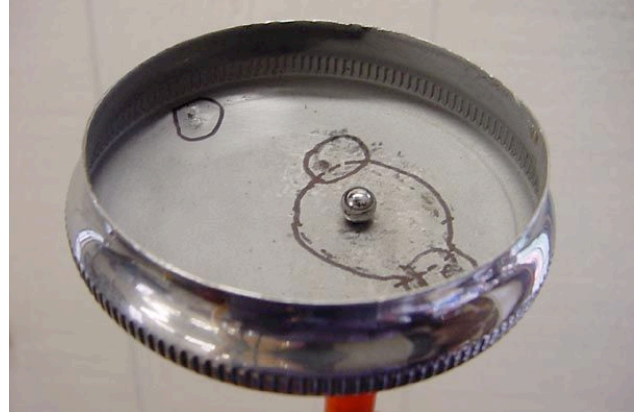
Dremels are neat little tools, and I had one loaded with a small cut off wheel so why not cut the inner liner at a 45° angle (without cutting the stainless too badly on the inside), take small vise grips and bend the cut part in enough to use the vise grip and a small screwdriver to work the inner liner up and out. IT WORKED! This was done on a Eaton Cap.

I took a magnet retrieval tool and placed it on the outside dent, dropped a ball bearing into the cap which migrated to the center of the magnet, drew a circle around the ball bearing with a felt tip pen and this gave me a good "smack it here" area. Hey... that worked too.

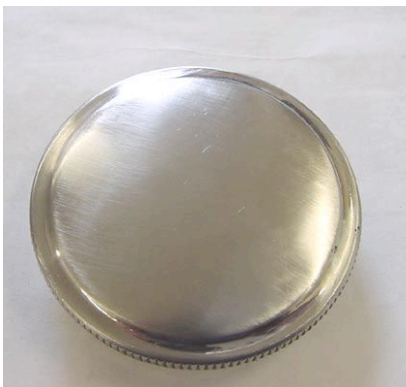
Before

A few months ago, Ed Case gave me some old original Model A gas and radiator caps full of dents and said "hey... see what you can do with these". They all had inner shells, which made it impossible to remove the dents from the outer shell surface. The word impossible really bugs me as I feel nothing is impossible so I reviewed one of my favorite quotes "Improvise sensibly as the situation demands" (which probably came from my brother Jim who has a gift for neat quotes and story telling). I tried soaking the cap liners with Kroil penetrate for a few weeks followed by big-brute vise grips on the inner center combined with my 3 foot pipe wrench. The result was not very pretty.

Then, I sand blasted the removed inner shell and inner portion of the outer shell. Where do I smack the outer shell to work the dents out?

On a roll now, I was able to push up all the dents, file the cap to reveal other low spots, sand with 320, 400 and 600 wet-or-dry paper and polish. I painted the inner cap with anti-rust silver and pressed it back into the outer using some Loctite blue medium strength.
