Subject: Seat Belts in 1931 Tudor Date: May 16, 2020 at 8:03 AM

1930-31 Tudor Sedan Seat Belt Location

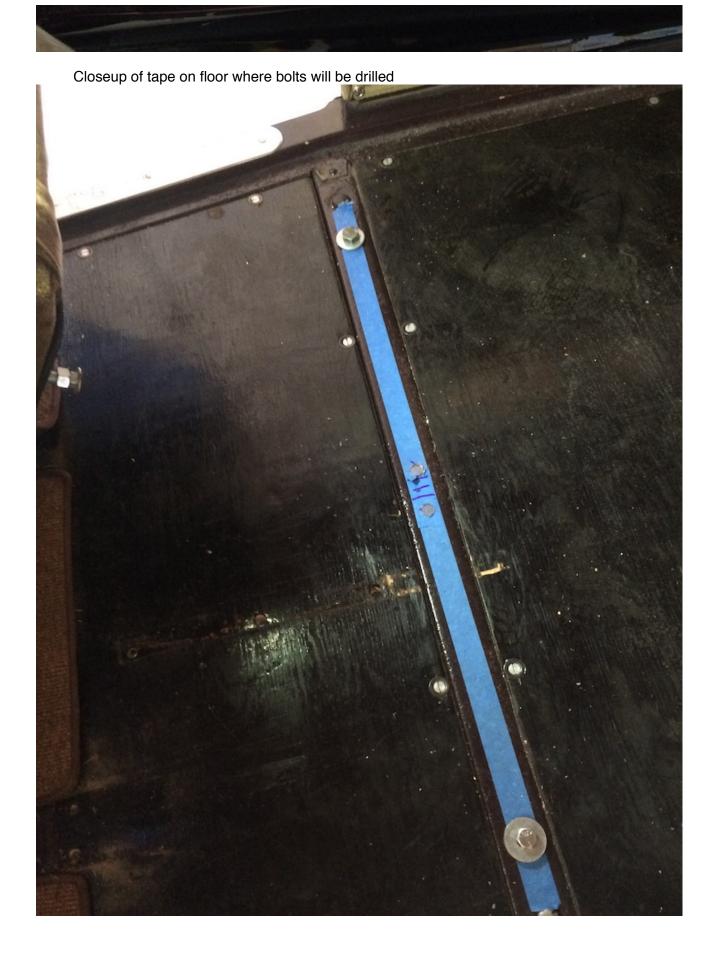
Hardwood support for under crossmember .75" thick, 26.75" long; 1.75" wide Two 1/2" holes 2 apart in center

Tape on floor where holes for 1/2" bolts will be located:

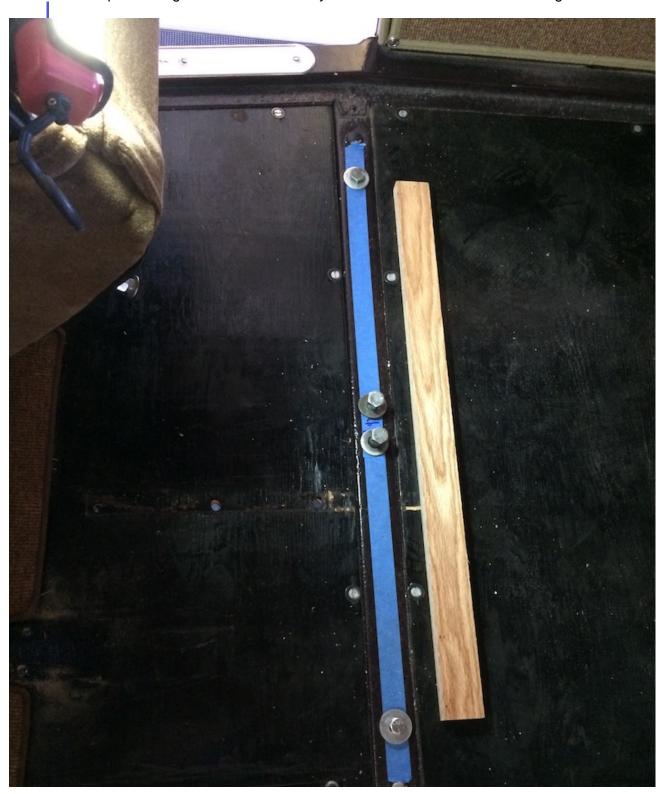
Wood strip that will go underneath the body crossmember to allow bolts to be tightened:

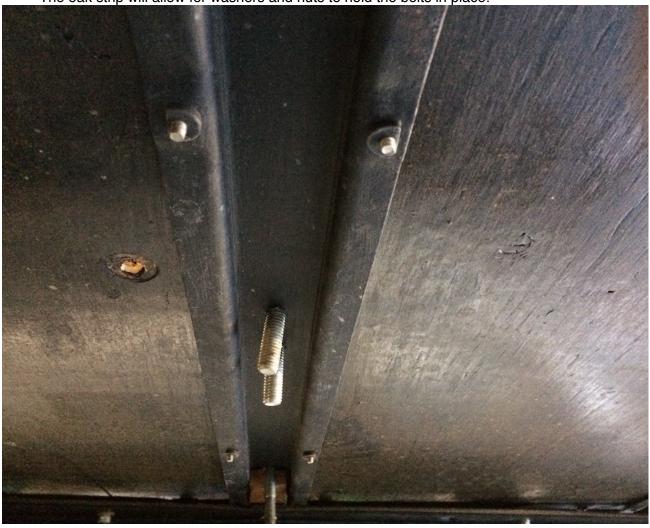
View from underneath the body crossmember showing bolts now in place. Drill holes in the oak strip to correspond to the bolt holes.

The oak strip will allow for washers and nuts to hold the belts in place:

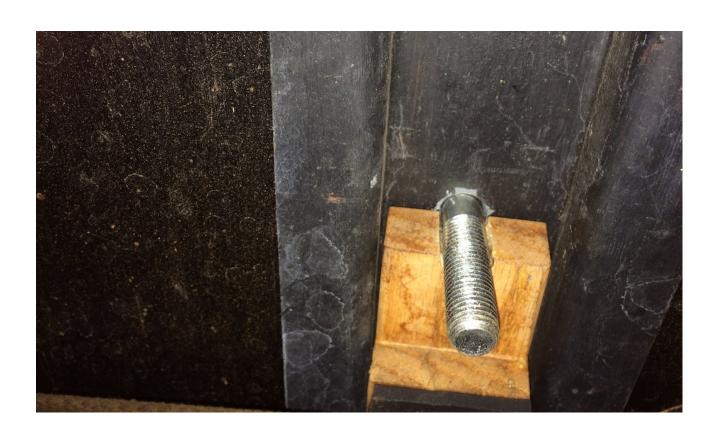
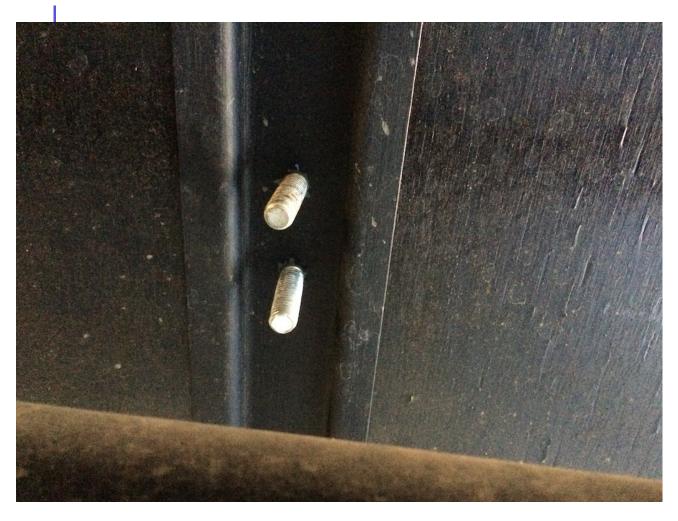
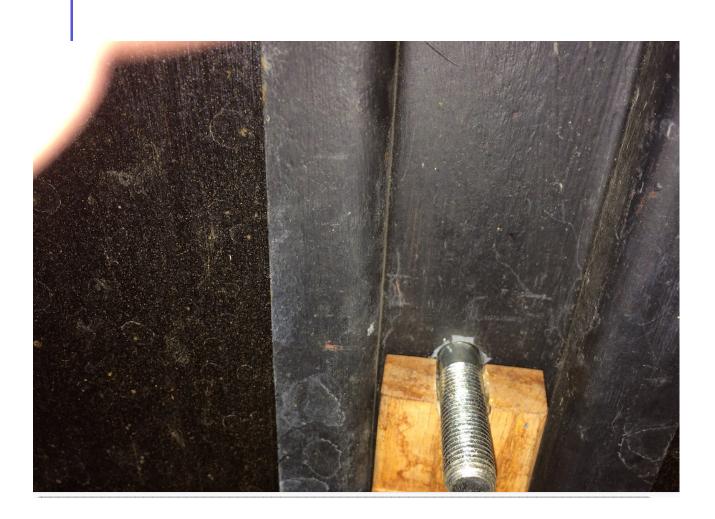
Existing side body blocks are now partially drilled for the mounting bolts:
