Subject: Mar 2020 New Model A Engine Update

New Engine

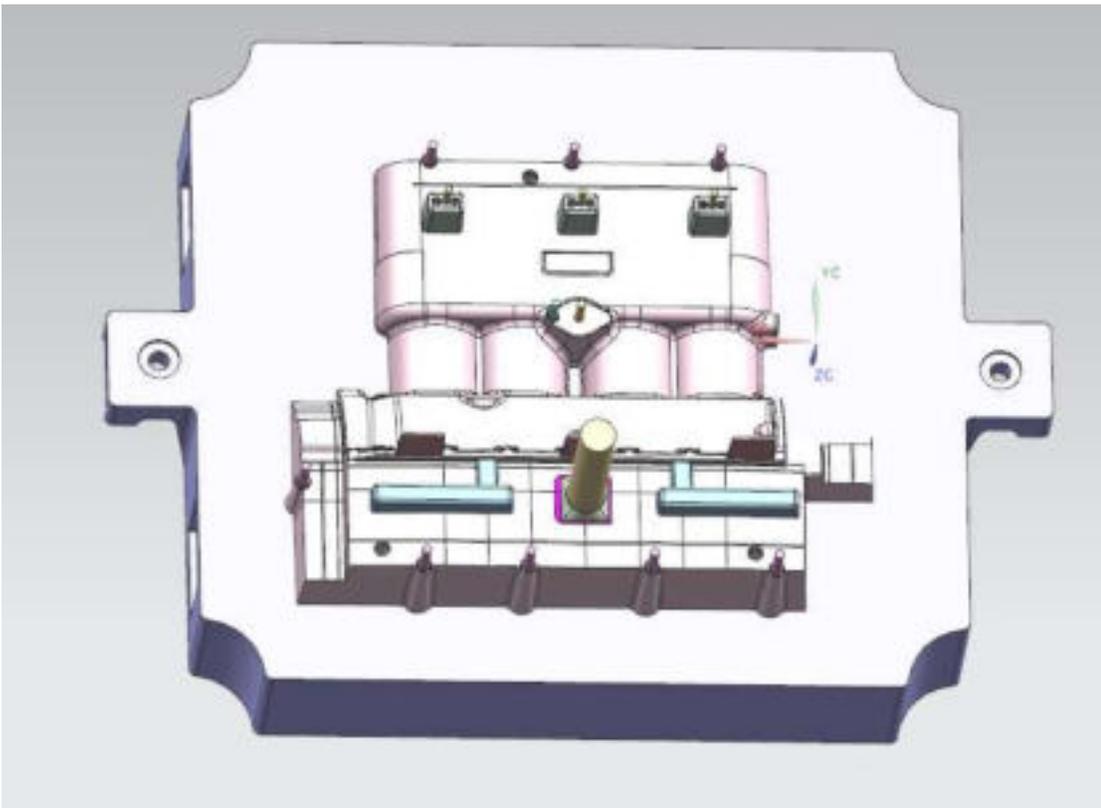
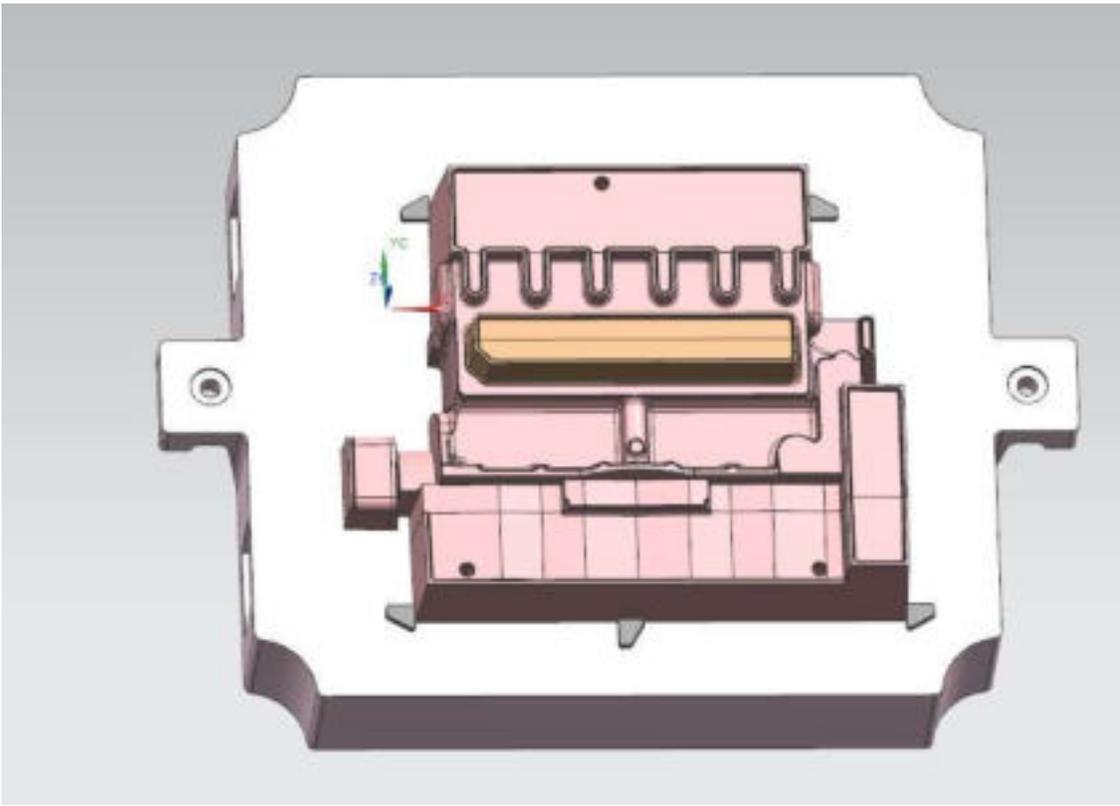
The 15 attached figures show what some of the tooling will look like. The first 2 figures show cope and drag patterns that are ready for automated molding, and the other figures show various stages of tooling completion. All tooling will be machined from aluminum.

Cylinder block foundry tooling is nearing completion. The factory in China has provided a schedule projecting completion on 18 April 2020. All tooling (core boxes, and the cope and drag patterns) is being CNC machined to the SolidWorks core and exterior models that have been provided by us. Everything that is external to the
